Oak Bluffs Harbor Oak Bluffs, Massachusetts

1. AGENCY USE ONLY (Leave blank)	2. REPORT DATE October 1991	3. REPORT TYPE AND DATES COVERED Reconnaissance Report		
4. TITLE AND SUBTITLE Navigation Improvement Study, Oak Bluffs Harbor, Oak Bluffs, Massachusetts, Reconnaissance Report			5. FUNDING NUMBERS

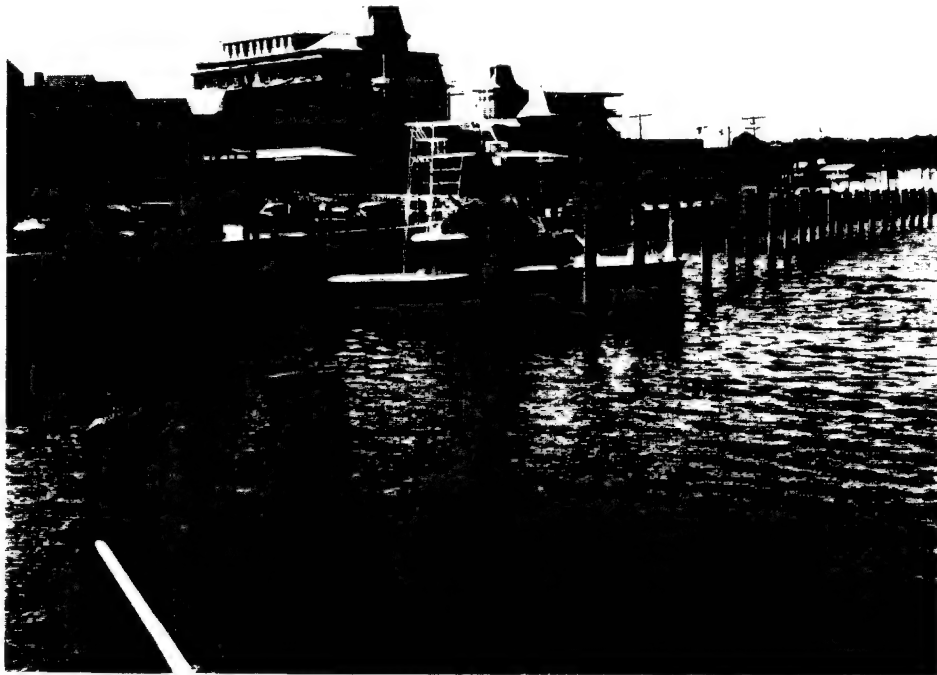
View of steel sheet pile bulkhead along south side of the harbor.

The present harbor configuration is characterized by numerous bulkheads defining its perimeter (see Figure 3). These bulkheads consist of steel and timber sheet piling. The south side of the harbor contains a steel sheet-pile bulkhead constructed in 1985 along Lake Avenue which is in good condition. The east side of the harbor contains a timber sheet pile bulkhead approximately 500 feet long and a steel sheet pile bulkhead (600 feet long) constructed in 1970 along Circuit Avenue. There is also a

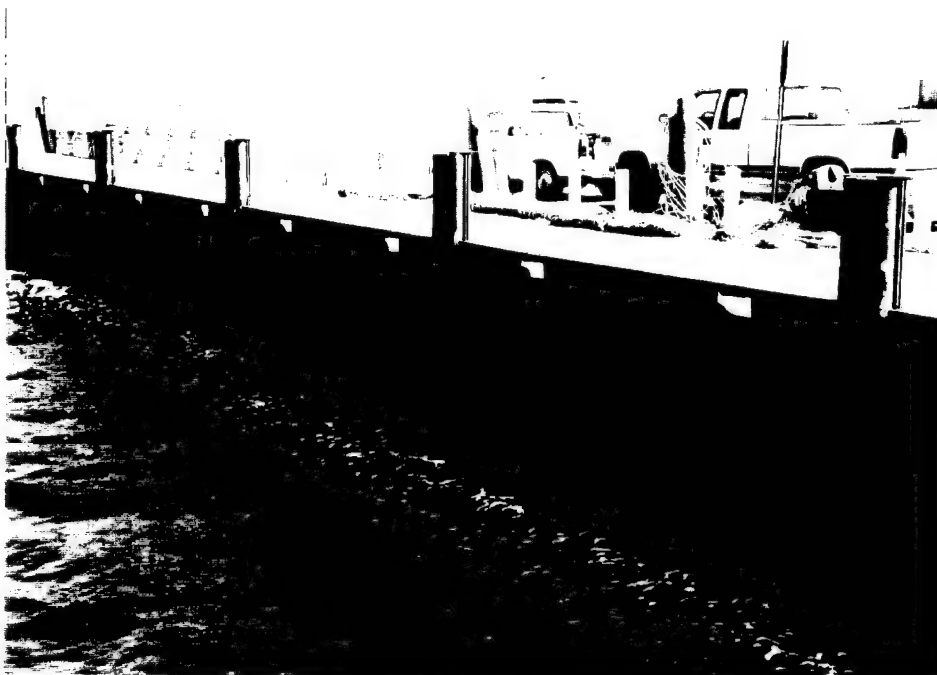
**Photographs
Oak Bluffs Harbor
Oak Bluffs, Massachusetts
Figure 3**

View of steel and timber sheet pile bulkhead along east side of the harbor.

The timber sheet pile bulkhead along the eastern portion of the harbor is where the commercial fishing fleet and passenger ferry services dock. It is also the area least susceptible to damaging storm waves propagating into the harbor. However, town officials are concerned about the condition of this bulkhead because of the continuing loss of backfill. Abnormal high tides and accompanying wave action caused considerable damage to this portion of bulkhead in early December, 1990. The storm reportedly caused wave heights within the harbor from 3 to 4 feet. Numerous areas exhibited a loss of backfill due to localized failures of the timber bulkhead. Some of these holes were 2-3 feet deep and over 3 feet across. This condition was also noted in the 1981 CE Maguire planning study. The town routinely fills the holes created by the loss of backfill and the timber decking was recently replaced along this portion of the dock. Town officials stated the need for a replacement bulkhead and are considering replacing the existing one with used steel sheet pile.

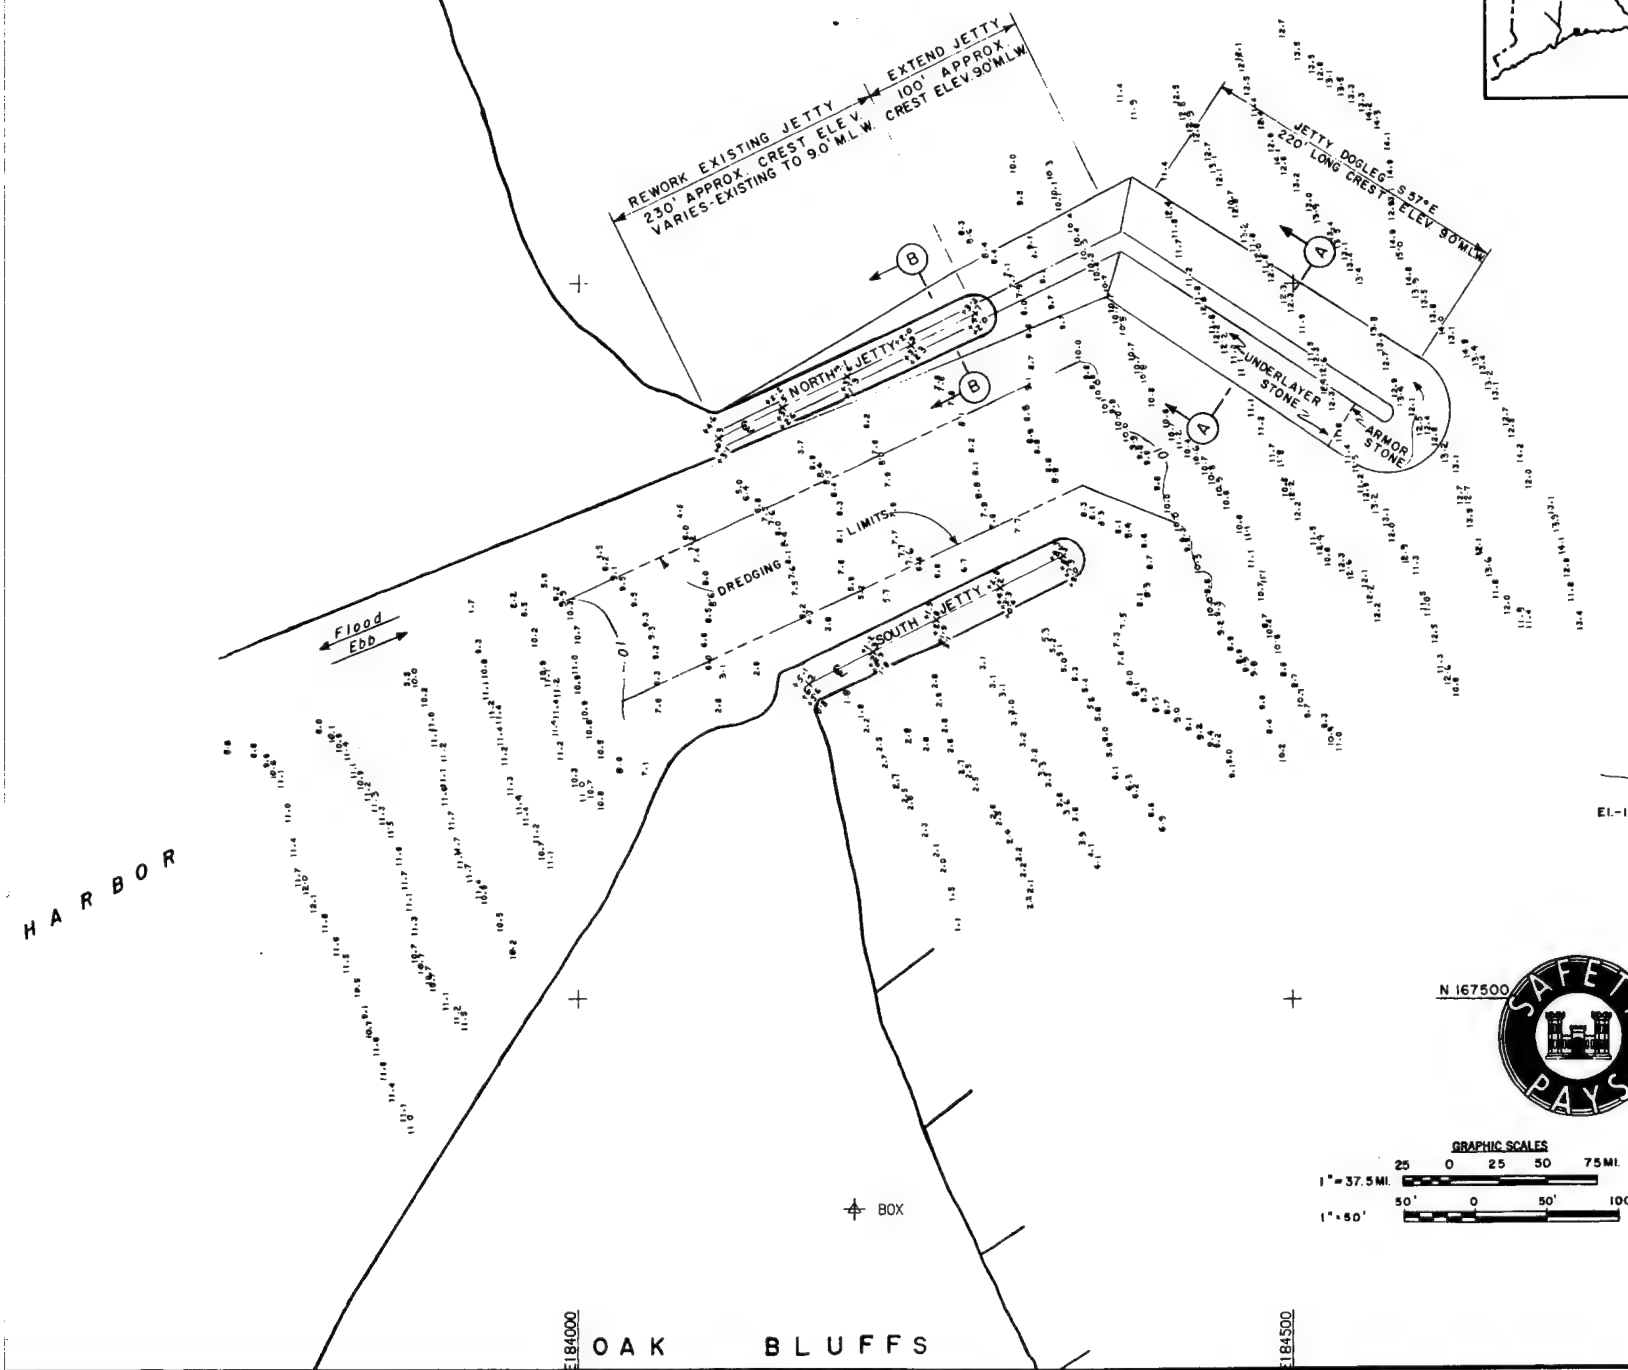
Soundings and elevations are in feet and tenths and are to the N.G.V.D. datum of 1929.
 Bathymetry from survey of September 1990.
 M. (1928) is set in drill hole on top of outcropping rock at View Park, near south curb of Ameskeac Avenue, between Sea View Avenues, 112 feet (34.1 m) from Sea View Avenue, 112.2 m) from Ocean Avenue and 3 feet (0.9 m) from curb of rue.
 Elevation is 15.26 feet above M.L.W.
 Coordinates are based on the Lambert Grid System for the Commonwealth of Mass., mainland zone and N.A.D. 1927.
 The sounding information depicted on this map is from hydrographic information conducted during Sept. 1990. This information should NOT be used for navigation purposes.
 The information depicted on this map represents the results of surveys the dates indicated, and can only be considered as indicating the conditions existing at that time.
 Fieldbook: R B H 4009.
 Hydrographic Roll: 90-158

The channel depth has been determined from a hydrographic survey of the harbor entrance (September 1990) that shows its shoalest point to be about 6 feet at MLW. According to town officials the channel entrance to the harbor has shoaled to a depth of 5.5 feet in some spots. The channel was last dredged approximately 12 years ago by the town. The channel is not a state maintained project.
